Navajo Abandoned Uranium Mine

Site Screen Report

Bec064 AUM Site

Navajo AUM Northern Region

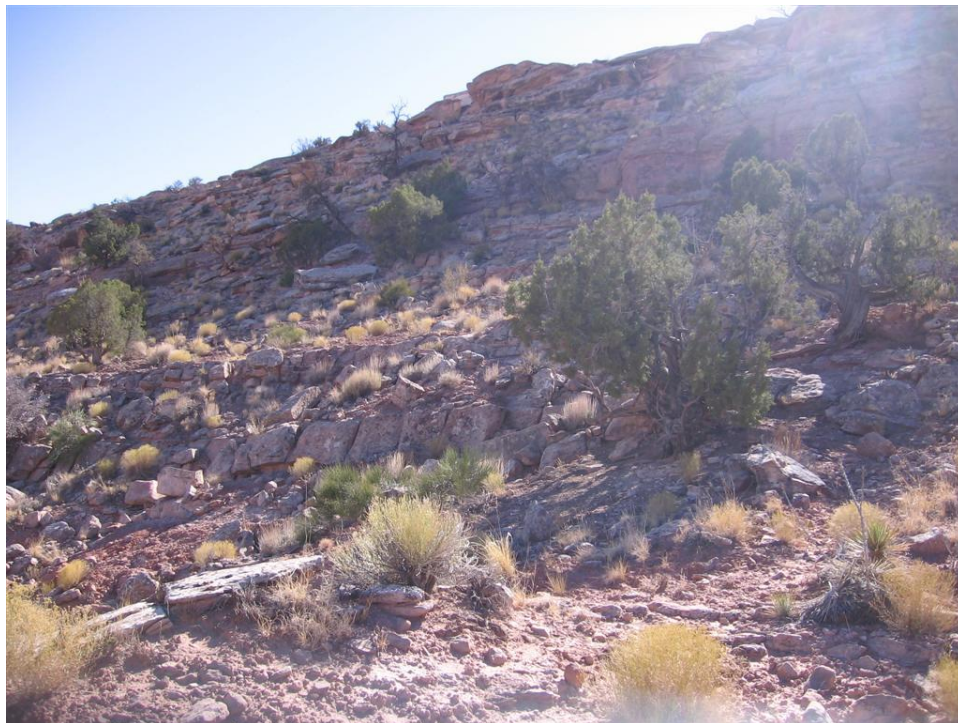
Photo 1. Mine site

Bec064 mine consists of an area of 11,666.75 m². The mine was not identified as ever being operational. No other historical information or any additional ownership / lease information was identified in the EPA/AUM database.

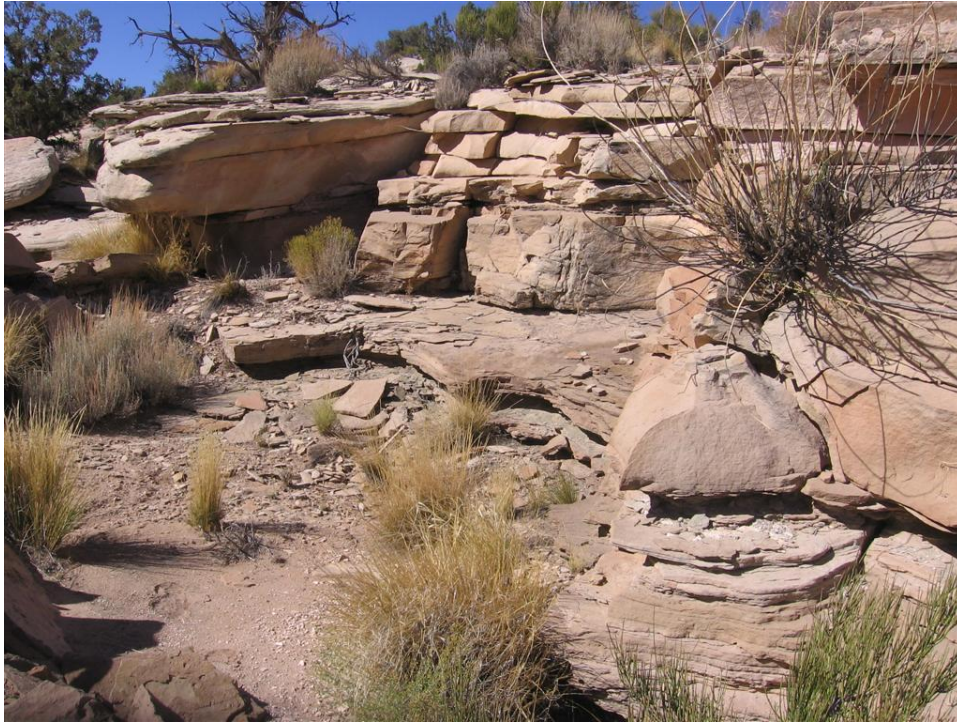
Photo 3. Waste pile

Waste pile extending 100' down to drainage, 100' x 50', with a total estimated volume of 926 yd³

Is there an unreclaimed waste pile at the site? Yes

Unreclaimed waste pile; possible pit area

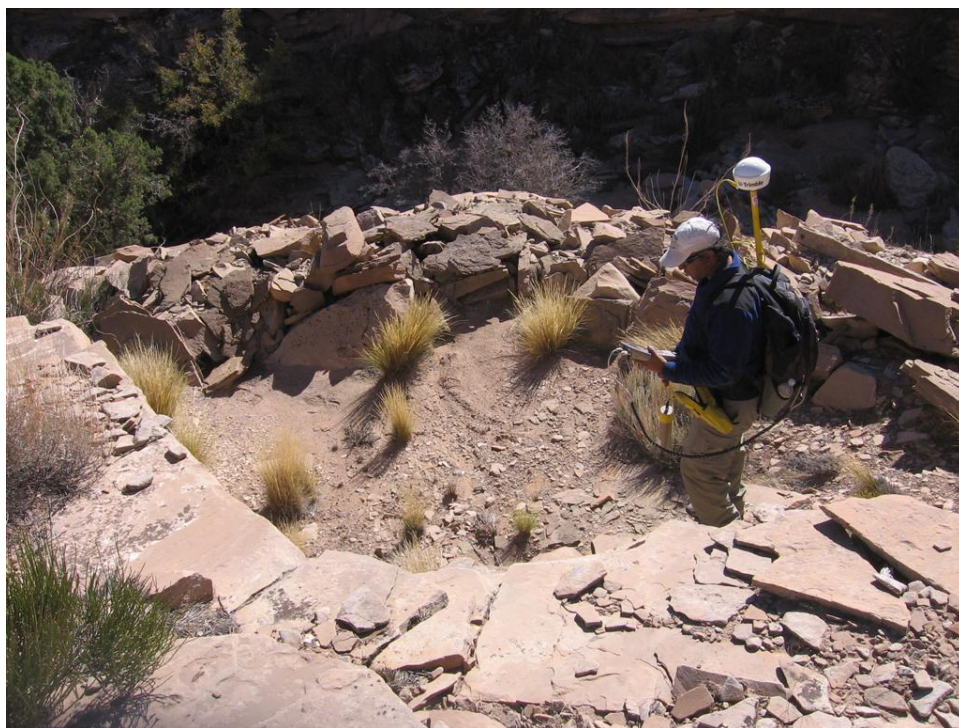
Photo 5. Possible pit area

Potential surface digging (pit)
